Anesthesiology 2008; 108:763-4

Backup Failure of an Adjunct Battery in an Evita 4[®] Ventilator

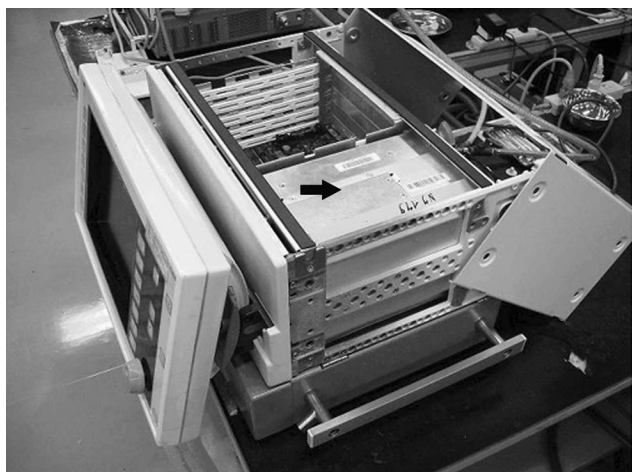
The AC and DC power modules of the ventilator were 8 yr old. The ventilator functioned steadily with an external power supply. Because the Evita 4[®] is normally configured to function for 10 min with backup from a fully charged battery in case of a power cut, the battery assembly was suspected to be responsible for the problem. The ventilator was sent to the manufacturers for close inspection to identify the source of the power backup failure. Dräger Germany found that the cable connector to an adjunct battery was eroded by leaked battery solution. Inside the moist electronic unit, the minor erosion had degraded the connecting cable over time and increased the electrical resistance, leading to the malconduction to the ventilator system and power failure even though the adjunct battery was properly charged

Fig. 1. The AC and DC power modules (arrow) are set in the electrical power unit of an Evita 4[®] ventilator (Dräger Medizin-technik, Lübeck, Germany).

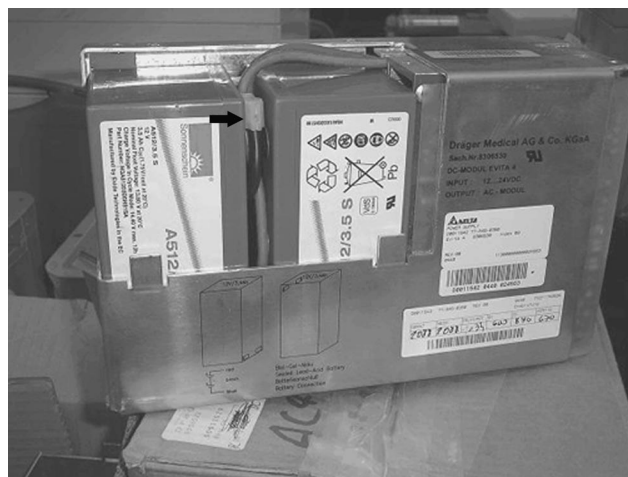
Fig. 2. A pair of the same type of batteries as the failed battery is placed in the adjunct battery assembly of the DC power module. The arrow indicates the cable connector to a battery.

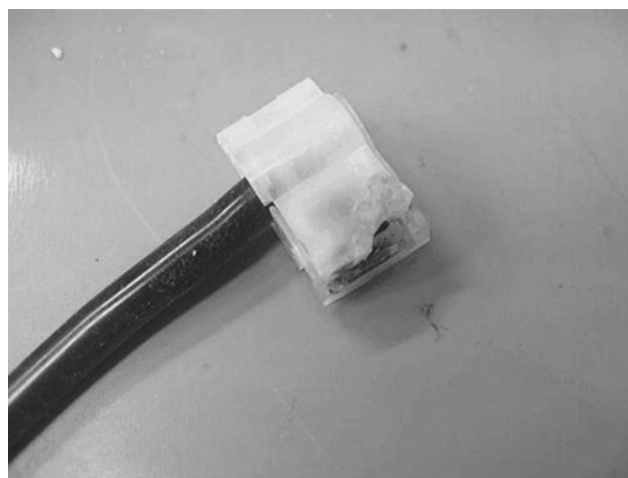
(figs. 1–3). Close examination of the manufacturer's database for batteries of approximately 10,000 serial numbers showed that the erosion occurred rarely. The current case was formally registered in the manufacturer's incident list. The manufacturer replaced the emergency power unit of the ventilator with a Panasonic lead-acid battery (Mastushita Battery Industrial, Osaka, Japan). Dräger Japan explained that all Evita 4[®] ventilators used in Japan would be inspected eventually, and batteries would be replaced, because there was a risk of leakage with the current battery unit.

Fig. 3. The eroded cable connector that caused the malconduction trouble.

ment of the battery assembly by trained technicians are mandatory. Moreover, we have to be aware that without reliable power supply, life-supporting machines such as ventilators would be lethal.²
