## A Case of Accidental Hypotension Caused by Drug Leakage through the Rubber Piston in a Prefilled Inovan Injection 0.3% Syringe

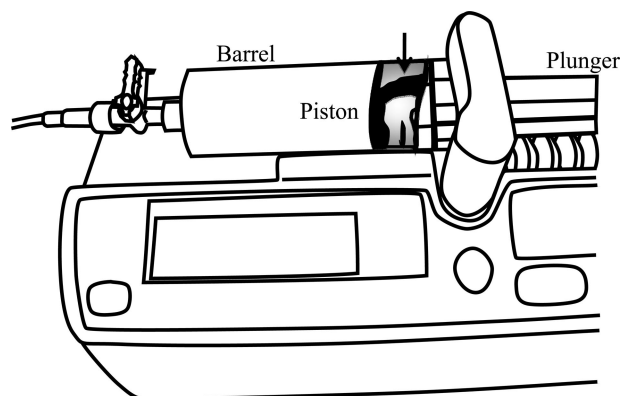
We sent the relevant syringe-infusion line assembly to the manufacturer for detailed inspection to identify the source of drug leakage and air influx, which appeared to occur at the piston that was fitted to the syringe barrel. We asked the manufacturer about the test results of the plunger/piston assembly that has been approved as medical equipment. The engineers responded as follows: They put the prefilled syringe in question to the liquid leakage test for syringe piston under compression in accordance with the International Organization for Standardization 7886-1: 1993-10-01.<sup>2</sup> There was no leakage in the rubber piston. Airtightness was maintained in the syringe, the extension tube, and the three-way stopcock. Next they examined situations that might produce drug leakage and how the leakage occurred during use of the prefilled syringe. The examination revealed the following: When the operator pushed the plunger into the rubber piston without turning it, there were some cases where the male screw thread molded at the top end of the plunger could not engage entirely the female screw thread molded on the inside wall of the rubber piston. Under this condition, the cylindrical rubber wall of the piston gradually became partially contorted as pressure was applied to the plunger after continuous infusion was started. This situation led to dislodging of the rubber piston, leaving a gap between the outside wall of the rubber piston and the inside wall of the barrel, and resulting in drug leakage as air entered through the gap (fig. 1). Consequently, the plunger/piston misassembly was proven to be the cause of erratic drug delivery, resulting in the abrupt onset of hypotension. The manufacturer had received the same incidental reports from several hospitals regarding the drug leakage from prefilled Inovan injection 0.3% syringes. They already had knowledge of the problem;

Fig. 1. Schematic representation of the situation in which a force applied to the plunger contorts the rubber piston when a prefilled syringe is used with a syringe pump. The gap (arrow) breaks the seal between the barrel of the syringe and the rubber piston, resulting in drug leakage as air entered through the gap. This plunger/piston misassembly caused an incident during drug administration.

We recommended that manufacturers provide a preassembled prefilled syringe with an integrated plunger/piston unit. However, the engineers indicated the following drawbacks of a preassembled prefilled syringe with an integrated plunger/piston: 1) Pressure may be exerted on the plunger during a fall or transportation of the syringe; 2) when the top film is peeled only partially during removal of the syringe, the finger grip may be caught by the film, resulting in tilting of the plunger with respect to the axial line of the barrel, which may cause plunger/piston misassembly; 3) the length of the whole unit becomes longer, posing problems in storage, transportation, and handling; 4) the manufacturers should apply to the Ministry of Health, Labor, and Welfare for changing a part of the original design, and approval will take more than 1 yr; and 5) the syringe pump structure may have to be modified to accommodate the newly arranged syringes. Based on these issues, Kyowa Hakko Kirin and Terumo are issuing appropriate warnings that the operator should not push the plunger into the rubber piston but should instead turn the plunger to engage the screw threads during assembly. They are also planning to modify the fundamental configuration of the plunger/piston assembly. We strongly recommend that the International Organization for Standardization, marketing companies, and manufacturers work together to supply prefilled syringes, particularly syringes with an integrated

plunger/piston, that are safe and carefully designed to prevent plunger/piston misassembly by the operator.

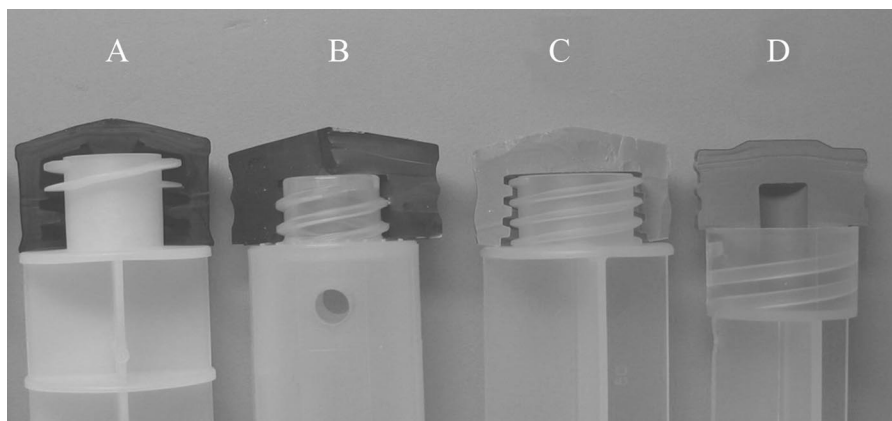
The cause of the present error in intravenous drug administration was probably attributable to the design of the piston/plunger assembly that varies between manufacturers. However, we have no precise information about their designs. We selected four different commercially available prefilled syringes and compared the configurations of their plunger/piston assemblies. In the case of the Inovan 0.3% injection syringe, only the uppermost part of the plunger head was molded with a small number of male threads, and the cylindrical wall of the rubber piston is thin. Under these conditions, the syringe is highly susceptible to contortion of the rubber piston during use and formation of a gap between the piston and the barrel. In contrast, in the cases of the Iopamiron Injection 300 syringe (iopamidol; marketed and manufactured by Bayer Healthcare, Bayer Schering Pharma, Osaka, Japan) and Nitrol injection for continuous infusion 25-mg syringe (isosorbide dinitrate; marketed by Eisai Co., Ltd., Tokyo, Japan; manufactured by Nipro Pharma Corp., Osaka, Japan), a deep portion of the plunger head is molded with male threads and the inside wall of the piston fits closely with the plunger head, leaving a narrow gap between the two.

Fig. 2. The design of the plunger/piston assemblies in four prefilled syringes. The plunger head fits into the rubber piston that is sagittally sectioned. (A) Prefilled Inovon 0.3% injection syringe (Terumo Corp., Tokyo, Japan). (B) Iopamiron Injection 300 syringe (Bayer Healthcare, Bayer Schering Pharma, Osaka, Japan). (C) Nitrol injection for continuous infusion 25-mg syringe (Nipro Pharma Corporation, Osaka, Japan). (D) 1% Diprivan injection kit (AstraZeneca United Kingdom, Alderley Park, United Kingdom).

In the case of the 1% Diprivan injection kit (propofol; manufactured by AstraZeneca United Kingdom, Alderley Park, United Kingdom, imported and marketed by AstraZeneca K.K. Pharmaceuticals, Osaka, Japan), the piston has the thickest rubber wall among the four products and contortion hardly occurs, and the male screw threads of the piston engage with the female screw threads molded on the top portion of the plunger (fig. 2). A piston with a thick rubber wall is less likely to contort during use. However, the engineers of Kyowa Hakko Kirin and Terumo indicate that the thick wall may affect internal syringe compliance, influence the force needed to operate the plunger *via* a syringe pump, and may be associated with irregular drug delivery.<sup>4</sup>
