In Reply:

In the letter, the authors discuss three cases pertaining to the Dräger Apollo® Anesthesia Workstation (Dräger Medical Inc., Telford, PA). In two of these cases they describe a nonfunctional manual ventilation at the end of a procedure after an otherwise uneventful mechanical ventilation. In a third case, they describe a nonfunctioning manual ventilation during the induction of anesthesia after previous spontaneous ventilation.

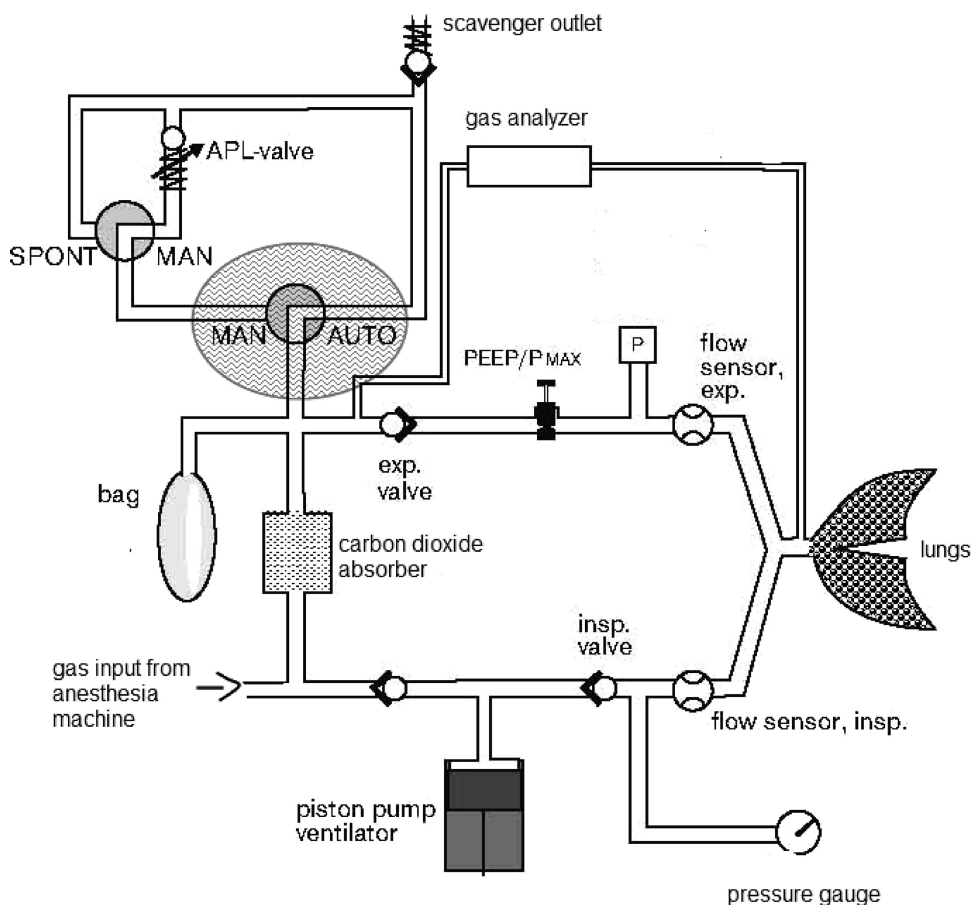
Fig. 1. Gas flow diagram: Dräger Apollo® Anesthesia Workstation. Modified from an original figure in the *Apollo® Operator's Instruction Manual, version 3*. Information furnished courtesy of Dräger. APL = adjustable pressure limiting; AUTO = automatic; exp = expiratory; insp = inspiratory; MAN = manual; P = electronic breathing pressure sensor; PEEP = positive end-expiratory pressure; P MAX = pressure limitation in volume mode; SPONT = spontaneous.

in Germany. Dräger stated they could not find any errors that could explain the failure-to-ventilate problem. They did not specifically mention what the error log might detect in relation to this specific type of problem. Dräger recommended replacing the inspiratory and expiratory flow sensor harness assemblies as well as the analog board and the expiratory sensor in case the problems were related to malfunction of any of the associated components.

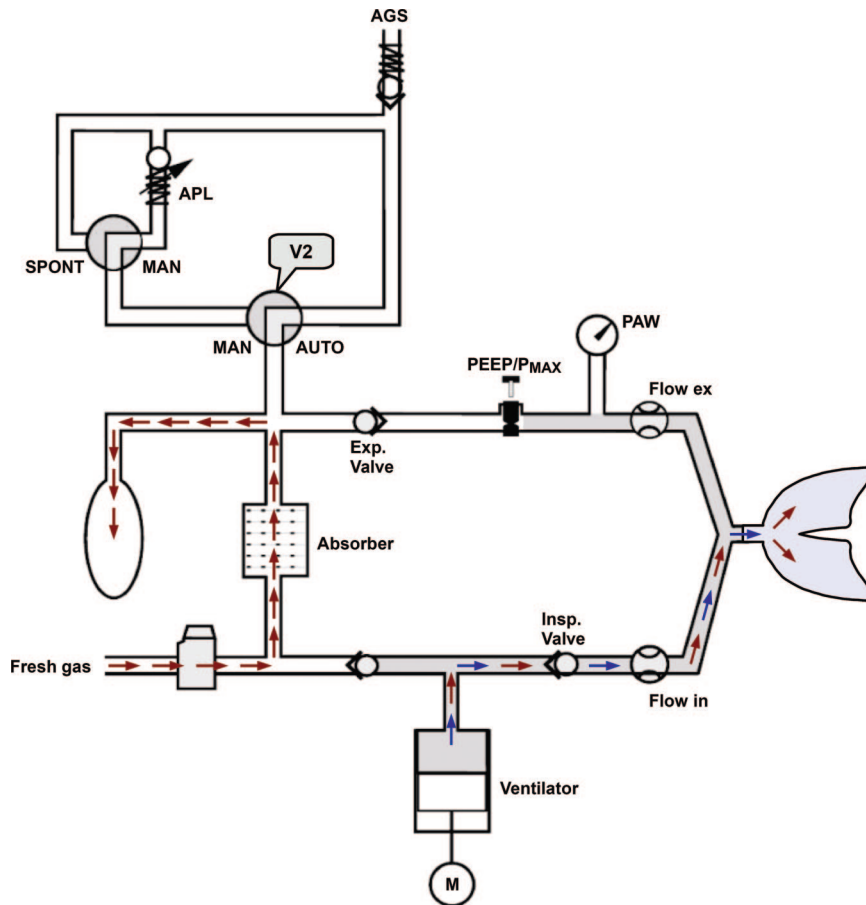
The authors speculate whether a fault of the “Man-Auto Bypass” valve may have caused it to stick in the bypass direction. In addition, the authors describe this valve as an electronic valve. This bypass valve (V2) is not an electronically controlled valve; instead, it is a pneumatic valve, which is activated by vacuum. Mechanically, valve V2 consists of a diaphragm with a base plate, which in its inactive state is pressed on a valve crater by a spring. In this state, which is equivalent to manual ventilation mode, the diaphragm closes the crater and thus the bypass path for the APL valve, which

Fig. 1. Gas diagram during inspiration. AGS = anesthetic gas scavenger system; APL = adjustable pressure limitation valve; Exp. Valve = expiratory valve; Insp. Valve = inspiratory valve; MAN/AUTO = reversing valve between manual/mechanical mode; PAW = airway pressure; PEEP/P MAX = positive end-expiratory pressure/pressure limitation valve; SPONT/MAN = reversing valve between spontaneous/manual mode.

results in the APL valve taking control of the airway pressure whenever V2 is closed.

Upon activation of automatic ventilation, a vacuum pump inside the ventilator evacuates a number of sections of the ventilator and breathing system, including the volume set up by the V2 diaphragm and valve housing. This causes V2 to fold back into its housing against the spring's force, resulting in its base being lifted off the crater and thus opening the bypass path of the APL valve. In this state, the APL valve is inactive, and pressure control is solely maintained by the positive end-expiratory pressure valve.

The functionality of mechanical ventilation also indicates that there were no other significant leakages in the pressurized part of the breathing system (see fig. 1).
