Clinical Workshop

A Defect in a Self-administration Anesthesia System

C. G. BALL, M.D.,* AND F. A. BERRY, JR., M.D.†

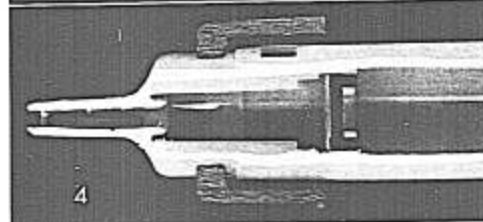
When the retaining ring is seated in the tube properly, the plastic disk cannot be dislodged from its point of action. However, during use, and particularly after cleaning, sterilization and reuse, the retaining ring, which is not immovably fixed in position, may shift slightly, providing enough room for the disk to find its way into the patient end of the mouthpiece and into the patient.

While the mouthpiece was originally designed to be disposable, it can be reused with proper sterilization, and the temptation to do so is difficult to resist. In many of the mouthpieces that had been used previously and then sterilized with Cidex,§ the retaining ring had migrated several centimeters and the plastic disk had migrated proximally (figs. 3 and 4) or was missing entirely.

FIG. 3. The retaining ring has slipped distally, allowing the disk to migrate towards the mouth.

Because of the serious nature of this defect, we feel that the design of the mouthpiece should be modified to prevent the disk from being displaced in any way by making the retaining ring immovable. In addition, it should be impossible for the disk, even if displaced, to travel out of the mouthpiece into the patient's mouth. This correction could perhaps

be accomplished by incorporating a plastic septum in the mouthpiece proximal to the plastic disk.
