## Clinical Workshop

### Electrocution in the Operating Room

DAVID H. ATKIN, M.D.,\* AND LOUIS R. ORKIN, M.D.†

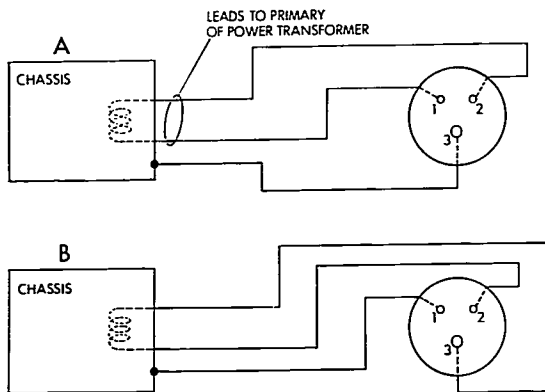
The EKG monitor and the power receptacles in the operating room were inspected. Figure 1A shows the proper wiring for a power plug and figure 1B shows the actual wiring of the plug. The chassis ground is connected to the "neutral" prong (no. 1) rather than the "ground" prong (no. 3). Figure 2A shows the usual wiring for a wall receptacle, and this was how the first receptacle was wired. Figure 2B shows the reversed-polarity wiring of the second receptacle.

When the faulty plug was used with the first receptacle, the chassis was connected to the neutral side of the power line. The EKG "ground" lead was thus connected to the neutral line. Since the voltage difference between neutral and ground is of the order of one volt in this system, no serious shock occurred. When the faulty plug was connected to the reversed polarity of the second receptacle, the chassis, and hence the EKG ground lead, was at about 110 volts with respect to true ground. Figure 3 shows the complete circuits causing

FIG. 1. A, correct wiring; B, faulty wiring.

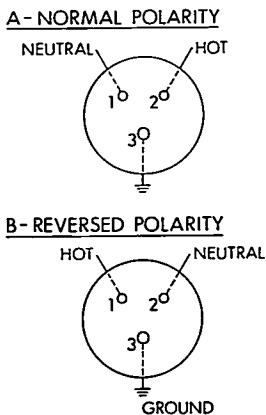
FIG. 2. Wiring of power receptacles. Positions 1, 2, and 3 correspond to those in figures 1 and 3. A, first receptacle—normal polarity; B, second receptacle—note reversed polarity of positions 1 and 2.

Because the improperly wired EKG monitor had been in use for some time without a shock reported, we thought that the receptacle with reversed polarity must have been the only one so wired in the operating rooms. The building code for this city has no requirements for standardized-polarity wiring in hospitals, and at the time this hospital was built there was no requirement for separate ground conductors; conduits were used instead. We tested all receptacles and found that 20 per cent of those in the operating rooms had reversed polarity, which probably had been present for the 15 years since the hospital was built. This has since been corrected.

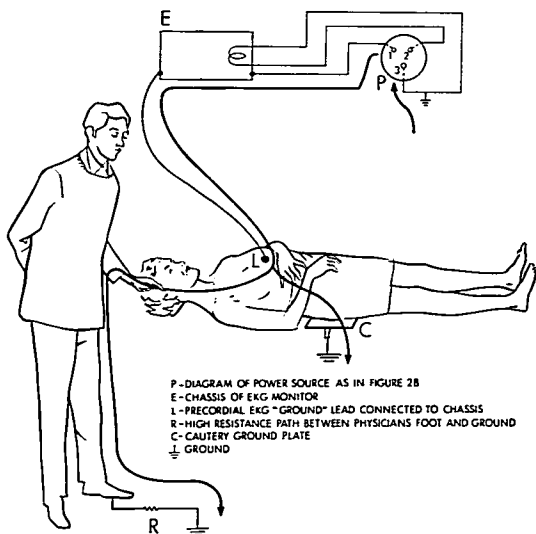
the shocks to both the patient and the physician. Between the precordial EKG lead and the electrocautery ground plate at the buttocks, 110 volts ac developed, with a resistance small

enough to permit sufficient current flow to electrocute the patient. The path through the physician was of much higher resistance. This was because of high resistance contact between her skin and the patient's skin, high resistance contact to the conductive floor, and high resistance from the conductive floor to the true ground. The intensity of current through this path was thus limited to several milliamperes, causing only discomfort. The physician could have suffered a more severe shock had she provided lower resistance to ground through another chassis, for example, a suction machine.

FIG. 3. Pathways of shock current. The heavy line traces the completed circuits between prongs 1 and 3. Both patient and physician provide connections to ground. About 110 volts ac existed between prongs 1 and 3, i.e., between precordium and ground plate.

through the trunk, especially the precordium. The "left leg" lead of the EKG in this case was attached precordially. During "lead 1" monitoring, this precordial lead becomes "grounded" to the chassis of this type of monitor and, therefore, was the electrode supplying the line voltage to the patient. It is recommended that precordial leads for EKG monitoring be avoided and that only limb leads be used.

Isolated power systems are now being used in many patient-care areas. The isolation transformer and the line-isolation monitor offer protection against macroshock hazards such as the one reported here. The leak from power line to chassis is detected by this system, providing a warning before the equipment is used on a patient.
