## Correspondence

### Defect in a T-fitting Connection

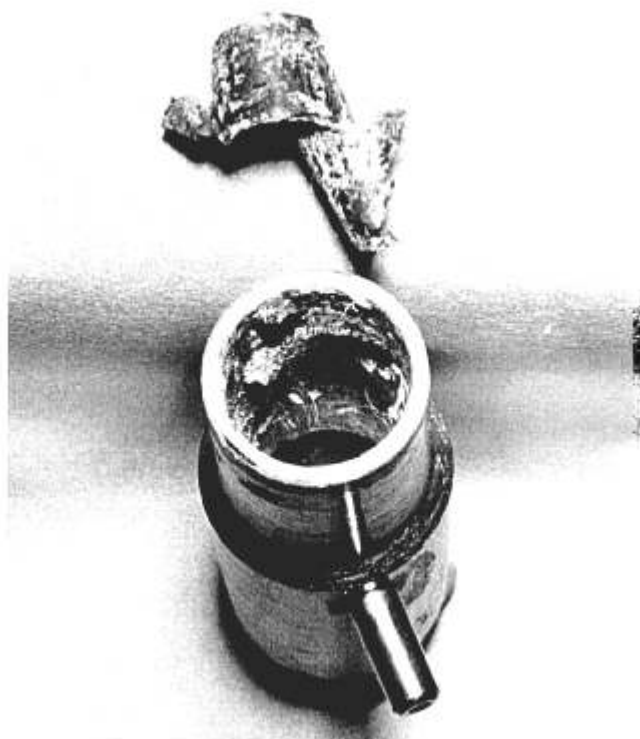
*To the Editor:*—The Ohio Anesthesia Ventilator has a metal T-fitting (Part No. 219-7486-800) designed for insertion between the endotracheal tube slip joint and the breathing-hose Y-piece. This T-fitting provides a connection between the breathing circuit and the low-pressure disconnect alarm system of the ventilator. Routine inspection of one such T-fitting in daily clinical use in one of our operating rooms recently revealed extensive corrosion and pitting of the inner lumen, as well as gross detachment of much of its metal plating (fig. 1).

This equipment defect presents the potential hazards of obstruction of the breathing circuit and, even more serious, inadvertent pulmonary aspiration of metallic foreign bodies during anesthesia. We were able easily to dislodge the coiled, 4-cm fragment of metal plating shown in the photograph. The fragment proved to be radiopaque. Had inadvertent dislodgement taken place intraoperatively, the consequences to the patient could have been disastrous.

FIG. 1. Corroded T-piece with coil of dislodged metal plating.

The manufacturer\* of this equipment has been notified of the problem. All T-fittings of the type described here require careful inspection, and replacement with a non-plated solid metal or plastic T-fitting should be considered.

*In reply:*—Ohio Medical Products is aware of the situation cited in the letter of Doctors Gold and Muravchick and is in the process of replacing all plated aluminum sensing tees with stainless steel tees.

All Ohio aluminum distal sensing tees should be inspected for loose plating, and the loose material removed by scrubbing with a hard-bristle brush. Tees manufactured after mid-1978 were made of stainless steel and are not involved.
