Anesthesiology
58:584-585, 1983

Potentially Fatal Machine Fault

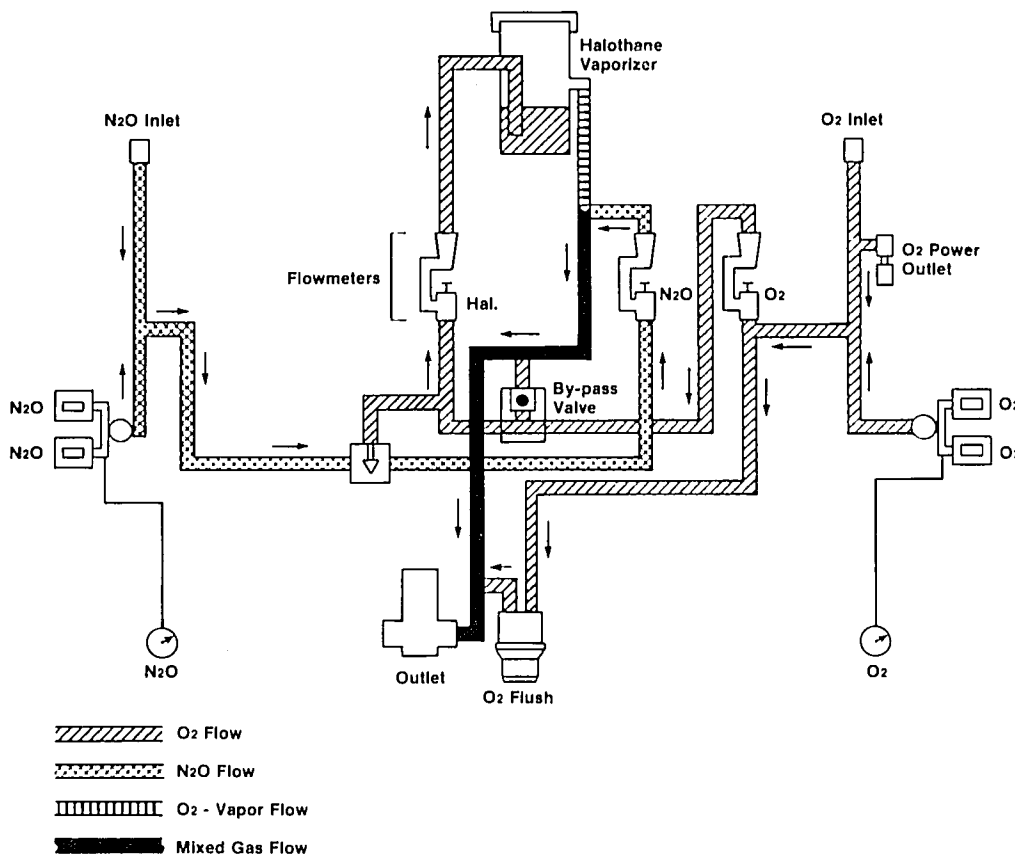
FIG. 1. The Ohio DM5000 machine.

The cause of the malfunction was later identified as a faulty bypass valve through which the flowmeter oxygen (but not the nitrous oxide or the oxygen flush) was exhausted to room air. In the Ohio DM5000 machine, oxygen supply flows both to the oxygen flowmeter and the oxygen flush valve (fig. 1). Flowmeter oxygen passes through a bypass valve both to the outlet and to the vaporizers. Nitrous oxide supply flows through the nitrous oxide flowmeter, joins the vaporizer output, and passes to the gas outlet. Oxygen not delivered to the vaporizer flows through the bypass valve and joins the nitrous oxide-vaporizer outlet mixture. "Oxygen Pressure Sensing Valves" (at one time called "FAILSAFE") within the machine normally prevent the flow of other gases in the event of loss of oxygen pressure. These valves only respond to the loss of supply pressure (wall outlet or tank supply) and not to the discharge of oxygen to atmosphere through a leak beyond the oxygen flow-

meter. Examination of the bypass valve reveals a side port intended for technician testing of supply pressure. The port was covered with a small plastic cap which blew off when the bypass valve stuck in the closed position. Thus, the oxygen was exhausted through the open port to the inside of the anesthesia cabinet. Following repair of the bypass valve, the test port was sealed closed.

In summary, a machine malfunction occurred in which the flow of oxygen through the oxygen flowmeter was diverted to the inside of the cabinet of the anesthesia machine. The flow through the oxygen flush valve was unaffected. Since oxygen pressures in the machine were not affected, the oxygen pressure sensing valves did not detect the malfunction and were ineffective in shutting off the supplies of other gases.

Consultation with the manufacturer revealed that Ohio DM5000 anesthesia machines manufactured prior to 1971 contain a bypass valve with a test port covered by a non-threaded plastic cap. These machines are therefore subject to the above described malfunction. Machines manufactured after 1971 contained a modification to prevent such disaster from occurring. Despite service at regular intervals, this machine had not been modified. In light of the above incident, we suggest that Ohio DM5000 machines be examined to ensure that such malfunction cannot occur.

We confirm Dr. Julien's statement that Model DM 5000s made after December 1971, were modified eliminating the plastic cap referenced in his article. Ohio Medical Products did have a field modification to replace the plastic caps that existed in the machines in the field. If your DM5000 has a serial number lower than number 1052 and there is a question if your machine has not been modified, please call your local Ohio Service Representative for an inspection.
