Anesthesiology
75:714, 1991

Another Potential Complication of a Pulmonary Artery Catheter Insertion

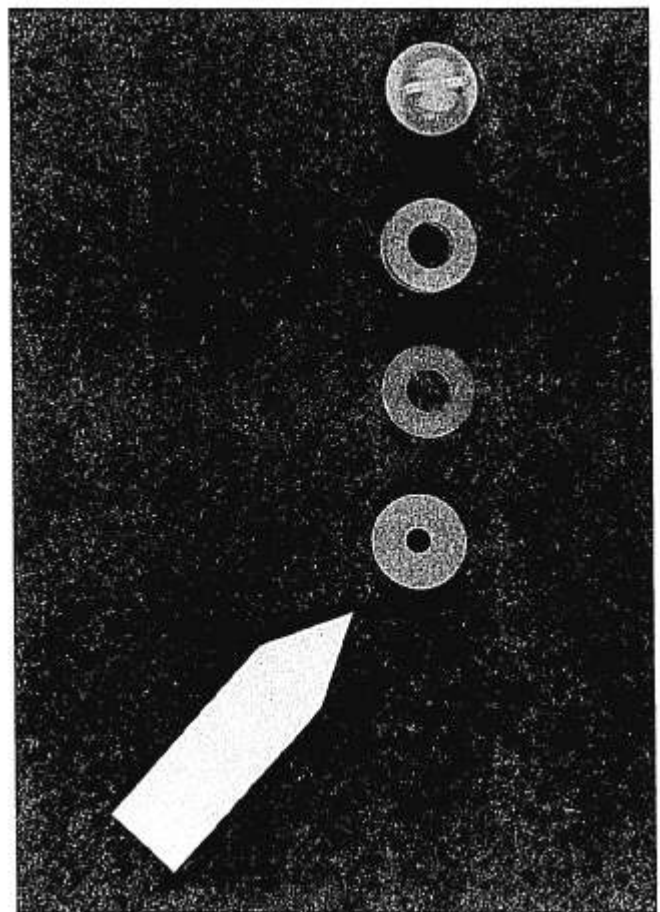
To the Editor:—We would like to report a case of a washer of a Tuohy-Borst valve (Baxter Healthcare Corp., Santa Ana, CA) dislodged into the sheath inserted in the right internal jugular vein. When the pulmonary artery (PA) catheter was inserted, persistent resistance to its further advance was encountered. Neither loosening the Tuohy-Borst cap nor reinsertion of the dilator was helpful. The wire was reinserted; the sheath was removed; and a new sheath was inserted without difficulty, followed by reinsertion of the PA catheter with ease. When the defective sheath was examined, the Tuohy-Borst valve was noticed to contain four pieces, as shown in figure 1. The distal rubber washer (fig. 1, arrow) had migrated to within 5 cm from the tip of the sheath, impeding insertion of the dilator. While examining the defective sheath outside the patient, further insertions of the dilator through the valve displaced this distal washer from the sheath *via* the tip. The washer is made of soft rubber, which explains how it was able to traverse the sheath. X-ray of the pieces in the figure revealed that only the third large washer is radiopaque.

In Reply:—The returned product was evaluated by our Quality Assurance Laboratory, and it was confirmed that the catheter seal had been pushed out of the Tuohy-Borst adaptor.

FIG. 1. The Tuohy-Borst valve assembly. The arrow indicates the distal rubber washer.

When difficulty is encountered during insertion of a PA catheter is not alleviated by loosening the Tuohy-Borst cap, we recommend immediate replacement of the sheath in order to avoid embolization of a potentially dislodged component of a Tuohy-Borst valve.

This specific problem has resulted in several corrective actions in the manufacturing process (*i.e.*, siliconization). In addition, the Tuohy-Borst duckbill valve and seals are being redesigned to prevent them from being pushed through the introducer.
