Double-lumen Tube Fire during Tracheostomy

To the Editor:—Ignition of polyvinyl chloride tracheal tubes by diathermy (electrocautery) is an uncommon but serious complication that has been previously reported.^{1,2,*} However, fire involving a double-lumen tube has not been described. We report a case of ignition of a double-lumen tube that occurred during elective tracheostomy.

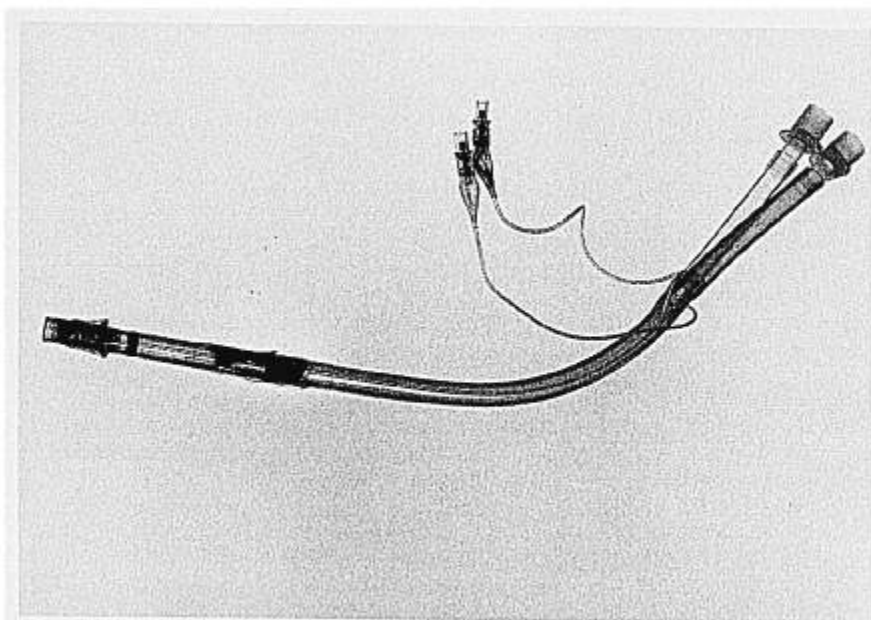
Throughout the operation, the FI_{O_2} was 1.0, and the PEEP was 10 cmH₂O. As the final incision was made through the tracheal wall with a diathermy pencil on coagulation mode, the tracheal cuff of the double-lumen tube burst and ignited intensely. The wound was covered with a wet swab, and the double-lumen tube was immediately withdrawn and replaced with a cuffed tracheostomy tube.

Examination of the double-lumen tube (fig. 1) revealed a 4.5-cm-long burn that was confined to the tracheal (proximal) cuff with small areas of molten plastic apparent within both lumina of the tube.

FIG. 1. The burnt left-sided Broncho-Cath double-lumen tube following removal.

We recommend that, if possible, the cuff of a single-lumen endotracheal tube should be advanced distally to the proposed tracheal incision, with care taken to maintain ventilation of both lungs, and that the use of diathermy during tracheal incision be kept to a minimum (if used at all). It is rare to perform a tracheostomy with a double-lumen tube *in situ*. Perhaps it would be safer to reinsert a single-lumen tube before proceeding to tracheostomy if diathermy is going to be used.
