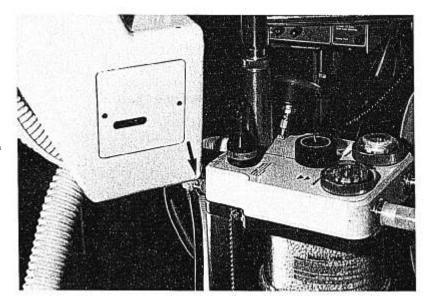
FIG. 1. C-arm of fluoroscope impacting the common gas inlet to the absorber manifold (arrow).

As shown in figure 1, the fluoroscope's C-arm had apparently cleared the absorber manifold but subsequently impacted the fresh gas inlet connector nipple. Radiology personnel were unaware that the anesthesia machine had been struck by the C-arm, which automatically continued to move into the desired position after the impact. A pressure-limiting sensor on the C-arm might have alerted personnel to the obstruction and avoided damage to the other equipment. Alternatively, protecting exposed plastic parts of the anesthesia machine may offer greater resistance to breakage. The site of damage was identified by noting the time-effect relationship of the C-arm movement and loss of pressure in the breathing system. Anesthesiologists also could be more cognizant of contact with their equipment from any motorized, moving apparatus, as they probably already are with the surgical table.
