Anesthesiology  
83:1352-1354, 1995  
© 1995 American Society of Anesthesiologists, Inc.  
Lippincott-Raven Publishers

## Disruption of an Infrared Capnograph Monitor by Hand-held Radio Transceivers

Juraj Sprung, M.D., Ph.D.,\* Daniel Siker, M.D.,\* Robert Koch, M.S.C.E.,† Patrick Beaudin, C.B.M.E.T.‡

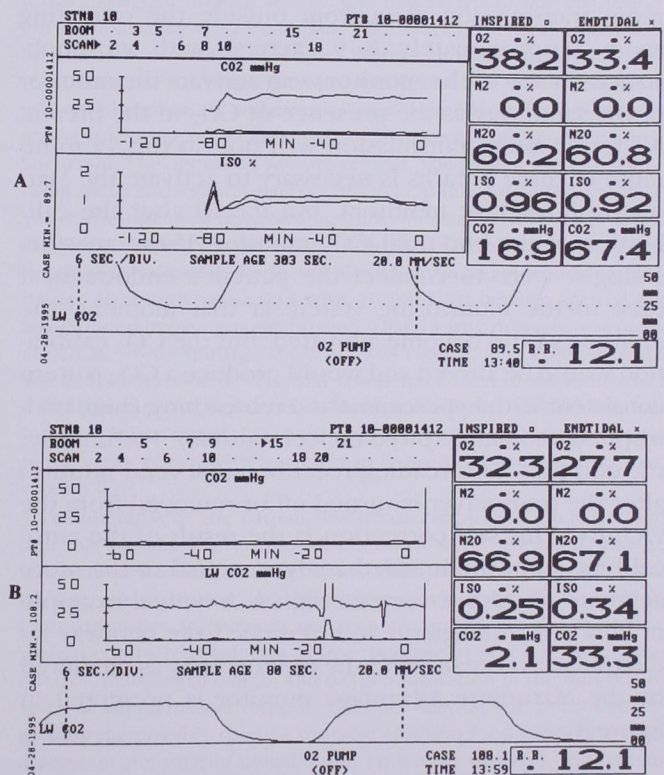
After the events described above (cases 1–3), we found we could reproduce the problem by transmitting with different transceivers at varying distances from the  $CO_2$  monitor (fig. 1). We were able to reproduce these changes from any place in our largest operating rooms (8–10 meters). The lead-shielded and grounded door of the operating room blocked radio-frequency interference when it was closed, but when it was open, we

Fig. 1. Capnographic tracings from an anesthetized patient after a 4-watt hand-held radio transceiver was activated 10 feet from the monitor and following its inactivation. (A) Less than 1 min after radio transceiver activation, the  $P_{iCO_2}$  appears to be 16.9 mmHg and the  $P_{ETCO_2}$  appears to be 67.4 mmHg. (B) The radio transceiver was turned off, and the falsely elevated  $P_{ETCO_2}$  (measured by the infrared analyzer) autocalibrated to the mass spectrometer signal (33.3 mmHg). The  $P_{ETCO_2}$  trends were obtained from the mass spectrometer (B,  $CO_2$  mmHg) and from the infrared analyzer (B, LW  $CO_2$  mmHg). The mass spectrometer trend indicated no change in  $P_{ETCO_2}$ . In the trend depicted by the infrared analyzer, immediately after the -20-min mark, the baseline of the  $CO_2$  suddenly shifted to approximately 20 mmHg, which coincided with activation of the radio transceiver. Over the next several minutes, the transceiver was not used and the infrared analyzer signal recalibrated its  $P_{ETCO_2}$  to slightly above zero, corresponding to the mass spectrometer signal.

These radio-frequency transmissions typically interrupted and distorted the end-tidal CO<sub>2</sub> waveform and then abruptly increased the P<sub>I</sub>CO<sub>2</sub> and P<sub>ET</sub>CO<sub>2</sub> readings to between 20 and 25 mmHg and between 65 and 75 mmHg, respectively. Occasionally, the monitor continuously displayed a P<sub>ET</sub>CO<sub>2</sub> tracing and a high CO<sub>2</sub> level, and a "no-breathing" warning appeared, such as in our second patient.

If the Advantage monitor is in a stand-by mode (as it is when not connected to the patient), a 5- to 10-s radio transmission even from outside the operating room (approximately 8–9 meters, with an unobstructed view of the monitor) can activate the monitor in the same way as the presence of CO<sub>2</sub> in the breath. A shorter radio transmission will not do this (a minimum of three breaths is necessary to activate the Marquette Advantage monitor), but it will alter the calibration of the end-tidal CO<sub>2</sub> monitor. If the anesthesiologist were to connect the patient's endotracheal tube to the monitoring system at that moment, the monitor would become activated, but the CO<sub>2</sub> calibration would be altered and would produce a CO<sub>2</sub> pattern consistent with hypercapnia and rebreathing (high end-inspired and end-expired concentrations). Fortunately, the end-tidal CO<sub>2</sub> reading recalibrates several minutes after the transceiver is turned off or removed from the vicinity. This self correction is the result of the auto-calibration of the infrared analyzer signal to the more accurate mass spectrometer signal. A typical example of how electromagnetic interference from two-way radio transceivers can affect the capnography as measured by the Marquette Advantage monitor is presented in figure 1.

In conclusion, radio interference from 4-watt hand-held radio transceivers can cause spuriously high P<sub>ET</sub>CO<sub>2</sub> readings on the Marquette Advantage monitor, shifting P<sub>I</sub>CO<sub>2</sub> reading from zero to between 20 and 25 mmHg. If these high CO<sub>2</sub> values are taken seriously, the patient may be mismanaged.
