Anesthesiology
62:207-208, 1985

A Case of Artifactual S-T Depression

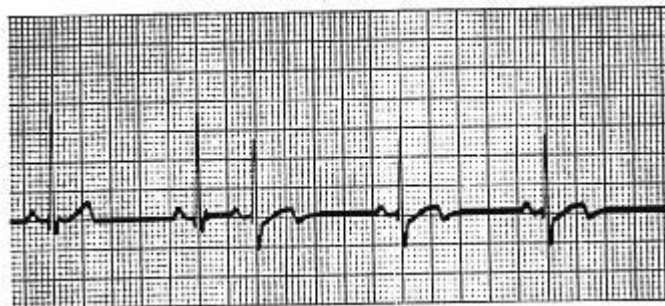
To the Editor:—Recently, during a routine cholecystectomy, new and significant S-T segment depression appeared on our Hewlett-Packard® #78304A ECG monitor. This occurred while we monitored lead II (fig. 1). Fortunately, the depression lasted only a few minutes and resolved spontaneously without treatment.

After resolution, we checked all the lead wire attachments; each was well secured. Then, accidentally, we found that minor movement of the patient cable holding the lead wires could produce or terminate the S-T segment changes at will.

The New Dimensions in Medicine (NDM) fully shielded ECG lead wire with snap electrode connector

FIG. 1. New and significant S-T segment depression and T-wave configuration change occurring with minor movement of the NDM patient cable: lead wire interface.
