The Dromedary Sign—An Unusual Capnograph Tracing

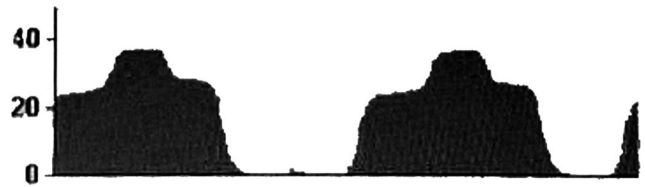
Fig. 1. A triphasic capnograph demonstrating the dromedary sign.

The measurement of end-tidal carbon dioxide is a fundamental component of patient monitoring during anesthesia. Any abnormalities must be noted, investigated, and treated accordingly. To our knowledge and subsequent review of the literature, the observed abnormal capnograph waveform (fig. 1) was unlike any previously reported. The gas analyzer in the Dräger Apollo anesthesia machine aspirates 200 ml/min (\pm 40 ml/min) of respired gases from the elbow connector at the Y piece through the sample line and water trap for the measurement of end-tidal gas partial pressures. Biphasic, dual-plateau

We hypothesized that this triphasic capnogram was a result of increased dyssynchrony between the positive-pressure phase of mechanical ventilation and the arrival of the end-tidal gas at the gas analyzer. During expiration, negative pressure at the crack in the water trap allowed room air to enter the sample, thereby decreasing the carbon dioxide concentration by sample dilution (first plateau). At the initiation of inspiration by the mechanical ventilator, the negative pressure at the cracked water trap is reversed as the piston exerts positive pressure (peak inspiratory pressure), represented by the higher plateau (hump). The higher plateau most accurately represents end-tidal carbon dioxide as sample dilution is eliminated. We hypothesize that the third plateau was due to the increased sample line volume. This increases the dead space and therefore the time between expiration and the arrival of end-tidal carbon dioxide at the analyzer. Assuming a 200 ml/min sample flow rate, a 1.5-ml increase in sample-line dead space could be expected to result in a 0.45-s increase in transit time. Thus, the positive-pressure phase of inspiration shifts to the left (longer transit time) in the capnograph waveform. At the end of the positive-pressure phase of mechanical ventilation, the expiratory carbon dioxide in the sample line is diluted again as a result of the leak in the water trap producing the lower plateau (third plateau).

Therefore, the transit-time delay caused by the addition of dead space in the sample line combined with a cracked water trap that aspirated room air into the expiratory gas sample resulted in the appearance of a midexpiratory hump on the capnogram. This case illustrates the need to understand capnography and the importance of machine checks given that erroneous end-tidal carbon dioxide measurements should be recognized to avoid inaccurate clinical decisions. The manufacturer may consider adding a machine check for the cracked water trap or any additional leaks from the circuit in the automated machine-check algorithm.

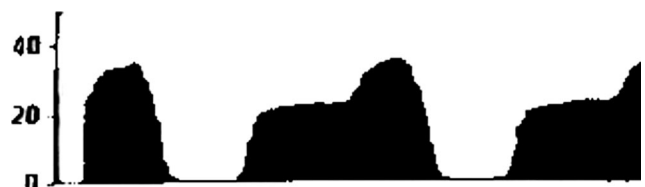
Fig. 2. An example of the capnogram after replacement of the original (modified) sample line (5.2-ml dead space) with a new standard length sample line (3.7-ml dead space). Note that the midcapnograph hump has moved to the right (shorter transit time) of the capnograph tracing.

of the capnogram (fig. 2). Next, the water trap was inspected and cracks were seen (fig. 3). Because a new water trap was not immediately available, the cracked water trap was wrapped with a 3M Tegaderm dressing (3M Health Care, St. Paul, MN) and reinstalled. This resulted in a normal appearing waveform (fig. 4).

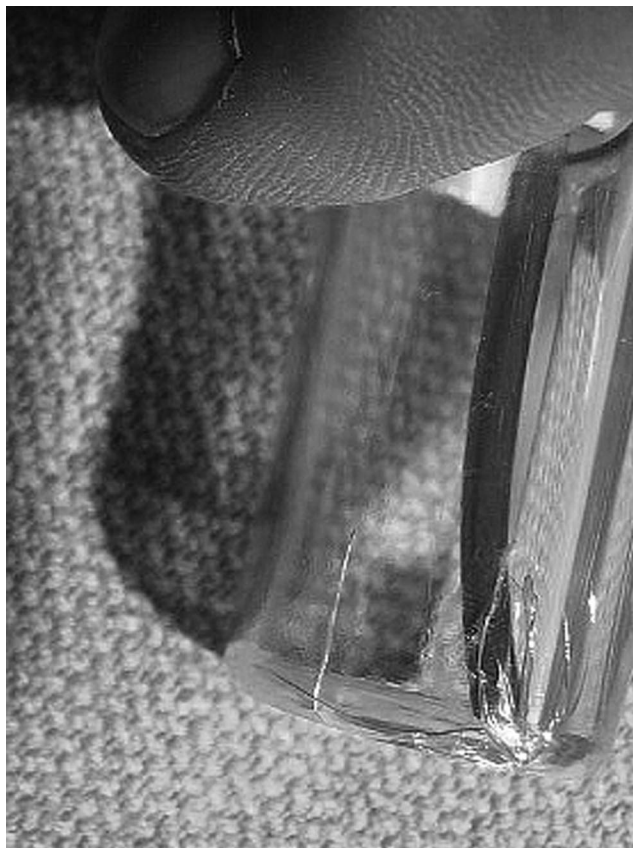
Fig. 3. Cracked water trap.

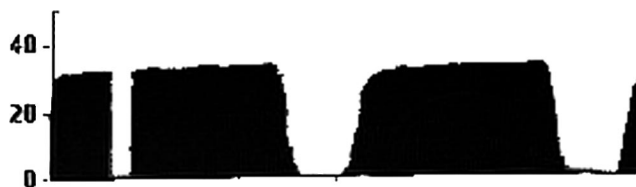
Fig. 4. Example of a normal-appearing capnogram after wrapping the water trap with a 3M Tegaderm dressing (3M Health Care, St. Paul, MN) and with a normal length sample tube.

To investigate the cause of the midplateau hump (or dromedary sign, given its resemblance to a single humped camel), we examined the gas sample line, which consisted of normal sample-line tubing (anesthesia gas sampling line, GE Health Care, Helsinki, Finland, 3 m or 10 feet, with a dead space of 3.7 ml) to which had been added a 24-inch arterial extension tubing (volume 1.5 ml; Hospira, Lake Forest, IL). To determine if this modified sample line contributed to the leak, we placed it under water in a high-pressure system; no leak was observed. By way of confirmation and to examine the effect of further increasing the sample line's dead space, we sought to recreate the dromedary sign in this same patient. We peeled the 3M Tegaderm HP dressing off the water trap and reinstalled it. We also reinstalled the original modified sample line. The abnormal capnograph waveform reappeared (see fig. 1). We then added a second 24-inch extension tubing (total length, now 14 feet; dead-space volume, 6.7 ml) and noted that the hump moved from the midplateau position to the left of the capnograph (fig. 5). After a new sample line without extensions and a new water trap were installed, a normal waveform was again observed (fig. 4).

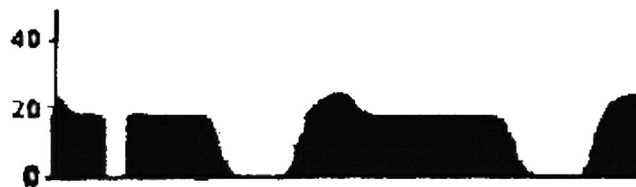
Fig. 5. An example of the capnogram after adding an additional 24 inches (additional 1.5 ml of dead space) of arterial tubing to the original (modified) sample line (6.7-ml total dead space). Note that the original midplateau hump has moved further to the left of the capnogram (longer transit time).
