## Metal Corrosion of Tracheostomy Apparatus

*To the Editor:*—Recently, a 60-yr-old woman presented to our emergency department with the complaint of an inability to insert the inner cannula of a metal tracheostomy apparatus. Her tracheostomy had been placed in 1985 after a cerebral vascular accident. The patient had been managing her own tracheostomy care since the

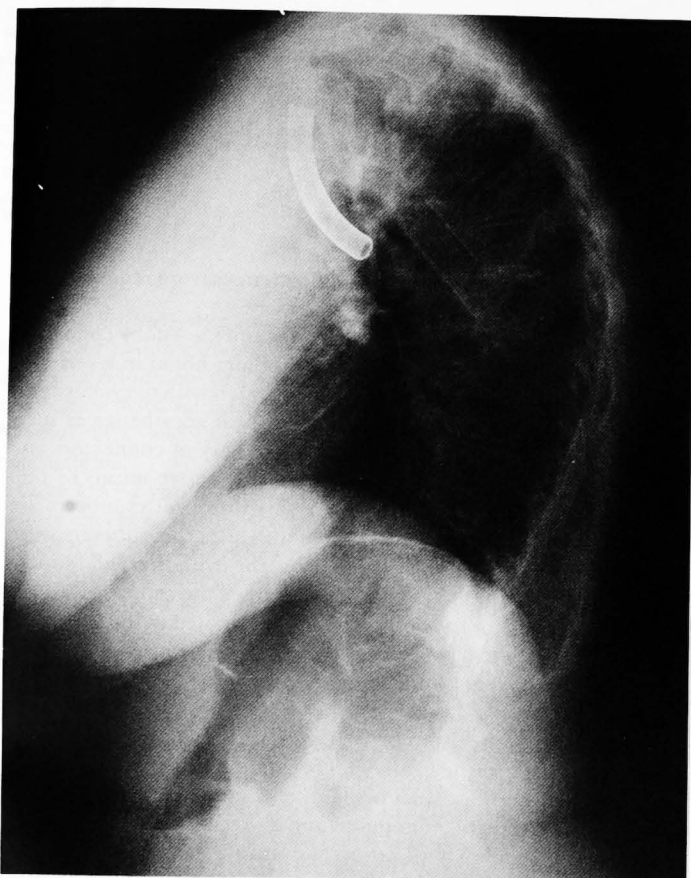
**Fig. 1. Chest x-ray showing outer cannula of tracheostomy apparatus lodged in right main stem bronchus.**

cannula lodged in the right mainstem bronchus with the distal end 2 cm below the carina (fig. 1). Both lung fields were well aerated with no evidence of atelectasis or pneumothorax. In the operating room after routine anesthesia preparation, the stoma was anesthetized with Cetacaine topical spray, and the cannula was easily removed with a foreign-body forceps. A new #6 tracheostomy tube was inserted after careful inspection of the stoma.

A metal tracheostomy apparatus often is incompatible with anesthesia circuit connectors, requiring anesthesiologists to substitute disposable plastic cuffed endotracheal tracheostomy tubes to allow positive pressure ventilation. At this point, our specialty can have some impact in reducing potentially fatal complications of the tracheostomy apparatus, such as that described above. After removal from the patient, every metal tracheostomy apparatus should be inspected for signs of wear, corrosion, and hairline fracture, especially at the junction of retention plate and tubular components. If a metal tracheostomy tube has been in use for many years, it may be prudent to replace it, thereby circumventing the possibility of fracture. It seems plausible to prevent this complication with regular inspection and replacement of the metal tracheostomy apparatus.
