Clinical Workshop

A Defect in a Self-administration Anesthesia System

C. G. BALL, M.D.,* AND F. A. BERRY, JR., M.D.†

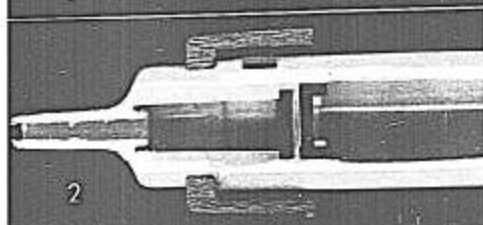
FIG. 1. The disposable nonre-breathing mouthpiece for the Juno Mark 2.

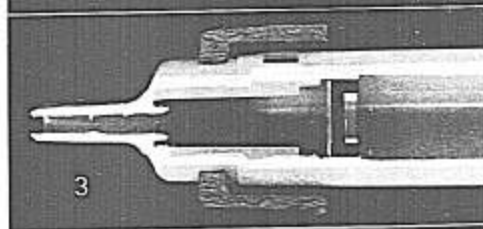
With increasing use of this technique, we have encountered a previously unsuspected and potentially dangerous complication relating to the mouthpiece. The mouthpiece is basically a one-piece plastic tube, narrowed at one end to fit between the patient's lips. In appearance it resembles a whistle (fig. 1). To prevent rebreathing of expired gases, a one-way valve has been incorporated close to the patient end. The valve consists of a small plastic disk held in place by a plastic retaining ring and small plastic ribs on the inside of the tube (fig. 2).

FIG. 2. Sagittal section of the mouthpiece, showing the normal positions of the retaining ring and disk. (Both have been colored for identifying purposes.)
