# Traumatic Atrial Septal Defect and Coronary Sinus to Left Atrium Fistula from Coronary Sinus Pacing Lead Removal

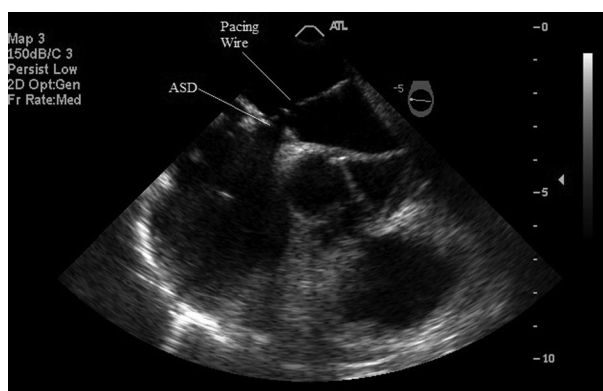
**Fig. 1.** The anteflexed four-chamber view revealed a new large atrial septal defect (ASD) near the fossa ovalis. A pacing wire was seen in the left atrium.

The fixation mechanism of the Medtronic 4195 lead could not be unlocked completely. Traction and countertraction through a Teflon sheath was unsuccessful. During this process, her systolic blood pressure suddenly decreased to 60 mmHg, and the patient desaturated to a low of 90% on pulse oximetry. Suspecting either a hemopericardium or a hemothorax, we administered albumin and 100 µg phenylephrine, which improved her blood pressure and oxygen saturation. However, findings consistent with a clinical diagnosis of cardiac tamponade or pleural effusion were not found after examination of the pericardial and pleural spaces with TEE. Surprisingly, the anteflexed four-chamber view revealed a new large ASD near the fossa ovalis (fig. 1). The pacing wire appeared to be in the left atrium. A bubble study with agitated saline showed passage of bubbles into the left atrium. Color flow Doppler ultrasonography demonstrated a large bidirectional flow jet between the atria (fig. 2; see video, showing a large ASD, Supplemental Digital Content 1, <http://links.lww.com/ALN/A596>).

After a standard sternotomy and institution of cardiopulmonary bypass, both atria were explored. A large tear (approximately 3 cm), involving the ostium of the coronary sinus with a linear cut in both the interatrial septum and the posterior left atrial wall with communications between the coronary sinus and the left and right atria, was identified. The coronary sinus was also found to be detached from the mitral valve annulus. The retained lead was transected, and the coronary sinus was reattached to the mitral valve annulus with a running suture. A patch of bovine pericardium was used to close the interatrial septal defect. No residual ASD or fistula was present on postoperative TEE. The tricuspid regurgitation remained unchanged. The patient was weaned from cardiopulmonary bypass easily and extubated on postoperative day 1. She recovered uneventfully and was discharged on postoperative day 12.
