# **Expiratory Limb Ventilation during Unique Failure of the Anesthesia Machine Breathing Circuit**

David M. Seif, M.D.,\* Michael A. Olympio, M.D.†

## GE Healthcare Response to Aestiva CO<sub>2</sub> Absorbent Cartridge Issue

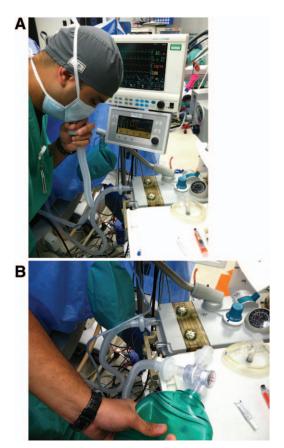
Fig. 1. (A) Reanimated photo of unadvised mouth-to-expiratory limb ventilation, showing the location of disconnection of the expiratory limb of the breathing hose and bacterial filter from the Aestiva/5 (GE Healthcare, Waukesha, WI) expiratory flow sensor. Realize that ventilation into the limb will cause: (1) closure of the inspiratory valve, (2) retrograde rebreathing of patient's exhaled gas, (3) additional "rebreathing" of anesthesiologist's breath, (4) no contribution of machine fresh gas, (5) no function of the adjustable pressure limiting valve, and (6) potential contamination of the circuit and anesthesiologist. Thus, there would be provision of subatmospheric (<21%) concentration of oxygen, in addition to inspired carbon dioxide, as seen in the background capnogram. (B) Reanimation of SIMVD ventilation of the expiratory limb. This would provide 100% O, from the SIMVD, added to the dead space of the exhaled patient gas remaining in the expiratory hose. Realize that the patient would exhale through the SIMVD exhalation valve. There is no mixing of exhaled gas into the oxygen reservoir. SIMVD = self-inflating manual ventilation device.

from the Aestiva/5 flow sensor and momentarily initiated retrograde mouth to circuit ventilation (fig. 1A), as the SIMVD was connected to auxiliary oxygen and then connected to the same distal expiratory limb. As the bag was squeezed, there was substantial and effortless chest rise with increasing oxygen saturation (fig. 1B). The patient remained hemodynamically stable on sufentanil infusion as additional help arrived. Another absorbent canister was soon delivered from the operating room supply room and normal machine ventilation was quickly reestablished. The remainder of the case was uneventful and

In summary, we used an escalating technique of (1) high oxygen flush to overcome a major circuit leak, (2) momentary mouth-to-tube ventilation of the expiratory limb, and (3) SIMVD to expiratory limb ventilation to successfully ventilate and oxygenate this patient for approximately 6 min, without threatening the integrity of the surgical field.
