## Thermal Burns Caused by Warming Blankets in the Operating Room

MARJANNE H. CRINO, M.D.\*, AND EUGENE L. NAGEL, M.D.†

Two cases are presented to direct attention to circumstances in which thermal burns can occur with use of warming blankets which are not defective and which are operating within "safe" temperature limits.

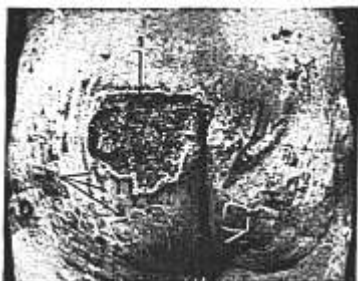
cent second-degree, with strips of second degree burn extending over the buttocks. The area of burn corresponded to the location of the warming blanket used during surgery and the pattern of burn to the fluid channels in the coils of the warming blanket (fig. 1).

FIG. 1. (1) Area of third degree burn, left sacrum; (2) burns corresponding to ridges of thermal blanket.

In both cases the most severe injury occurred in areas of greatest pressure, namely, over bony prominences. Both patients were diabetic, moderately obese, and had some degree of vascular insufficiency. Preparative solutions used for skin cleansing may have predisposed to this injury. The pattern of burn in each case corresponded exactly to the

area of contact and to the fluid channel spacing in the warming blanket.

Following these two incidents, four thermal blankets and accompanying control units were calibrated using a laboratory thermometer as a standard. All four units were found to be within manufacturer's tolerances which allow approximately 9 degrees F. differential between the control unit reservoir and the blanket surface temperature. In most temperature-control equipment designed for patient use, the maximum blanket temperature recommended is 105 degrees F. However, this manufacturer suggested a lower temperature

setting for patients having vascular insufficiency or diabetes and for infants. Recalibration of control units was recommended following impact or other mechanical abuse. Regardless of individual manufacturer's instructions, guidelines are not well established concerning variables such as length of procedure, patient weight, patient position, condition of patient (*e.g.*, diabetes, vascular insufficiency, etc.), patient age (infant), and temperature at the blanket-patient interface. Scott<sup>1</sup> presented three cases in which significant skin injury occurred following use of a thermal blanket during open heart surgery. He felt that the injury might have been compounded by pressure necrosis, because the areas involved were over bony prominences. In one case an electrocoagulating grounding plate was noted to have been in contact with the skin at the site of injury and may have acted as a heat conductor, thereby contributing to the injury.

It is concluded that for certain patients a lower temperature setting should be used, depending upon length of procedure, position, patient condition, and other factors. These limits have not yet been determined.
