## Failure to Detect CO<sub>2</sub>-absorbent Exhaustion: Seeing and Believing

Diane Pond, M.D.,\* Richard A. Jaffe, M.D., Ph.D.,† John G. Brock-Utne, M.D., Ph.D.‡

REBREATHING during general anesthesia is defined as an increased inspired pressure of carbon dioxide above 2 mmHg.<sup>1</sup> We report a case of rebreathing, with an unusual capnographic pattern caused by undetected exhaustion of the carbon dioxide absorbent.

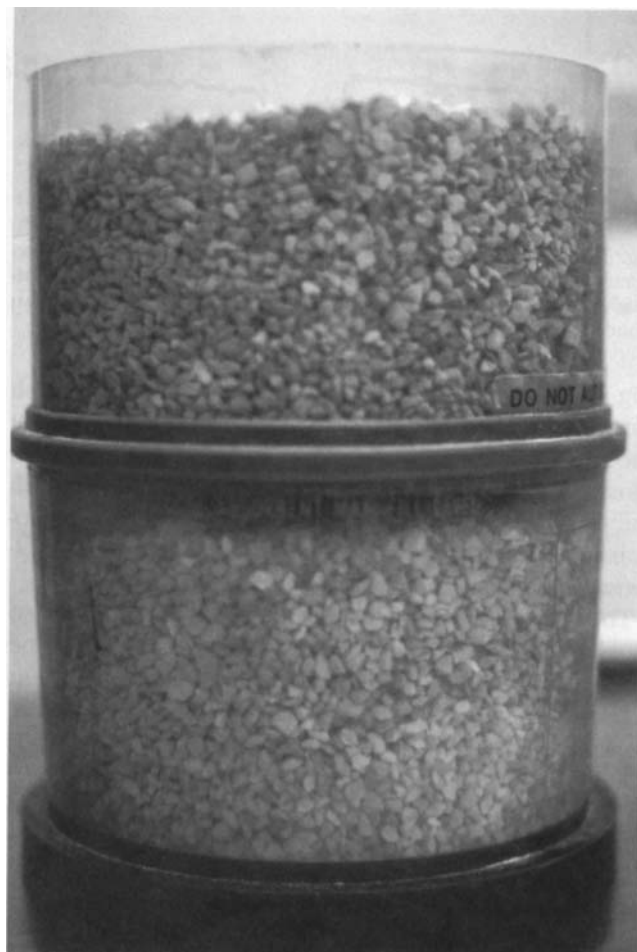
The first machine was disassembled, and the source of the problem was immediately identified as exhausted carbon dioxide absorbent in both compartments—the absorbent was uniformly and completely exhausted. The violet-blue dye indicator in the lower compartment had been filtered out by the yellow discoloration of the plastic canister, producing the appearance of fresh white carbon dioxide absorbent in that canister.

In this case, the color change was not detected because of the yellowing of one of the two transparent plastic absorbent canisters. The yellowed plastic filtered out the blue-violet wavelengths, giving the granules the appearance of the original white color, especially when compared with the blue granule color in the smoky clear plastic upper compartment. It was not until the canisters were opened that we discovered the intensely purple color of the completely and uniformly exhausted lower-canister absorbent. The original plastic canisters for the absorbers were made of acrylic, but because they could not be autoclaved, they were replaced in approximately 1984 with a yellowish polysulphone compound (part #410-5852) that could be autoclaved. In 1992, North American Dräger Medical, Inc. released a smoky clear polysulphone canister (part #410-5852). The yellow-tinted and smoky clear canisters used in this case were

Fig. 2. Although this black and white photograph fails to demonstrate the dramatic color difference between the upper and lower compartments, carbon dioxide absorbent in the upper compartment is blue, suggesting exhaustion of the carbon dioxide-absorbent granules. No color change is seen in the bottom compartment because of the yellow tinting of the transparent plastic absorbent canister. The yellow plastic gives the granules a white appearance.

manufactured by Dräger Medical Inc. After this case, we replaced all yellow canisters with the smoky-clear variety. Dräger Medical has been informed of our observation, and concurs with our solution. In our case, we think that a technician “cannibalized” a yellow-tinted canister from an older machine for use on the newer machine. By eliminating the older canisters, we think that this potential disaster will not occur again.

In summary, we report a simple case of absorbent exhaustion being masked by the color of a canister. Based on this experience, it is our recommendation that old yellow-tinted canisters (part #410-5854) be replaced with the new polysulphone canisters (also part #410-5854). Under no circumstance should the two types of canisters be used simultaneously on an anesthetic machine.

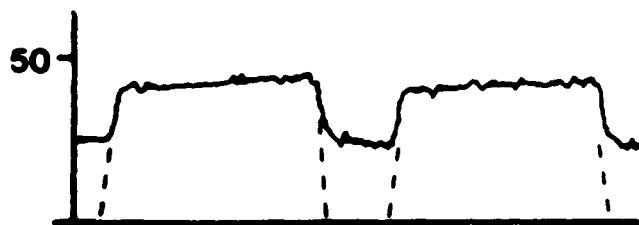
The expected capnogram tracing resulting from exhausted carbon dioxide absorbent is seen in figure 3.<sup>1</sup> Our tracing had an additional second peak that delayed diagnosis of the problem. We propose the following explanation for the unusual second peak. At inspiration

Fig. 3. Computer-assisted capnogram analysis showing the expected capnogram tracing resulting from exhausted carbon dioxide absorbent. Reprinted with permission from van Genderingen *et al.*<sup>1</sup>
